# DAVID HOLDSWORTH & ASSOCIATES

## VESSEL SURVEY REPORT

Vessel Name: **Sea Dog** Date of Survey: **September 15, 2014**

Type of Vessel: **Power Motor Yacht** Surveyed at: **Canal Boatyard, Seattle, WA**

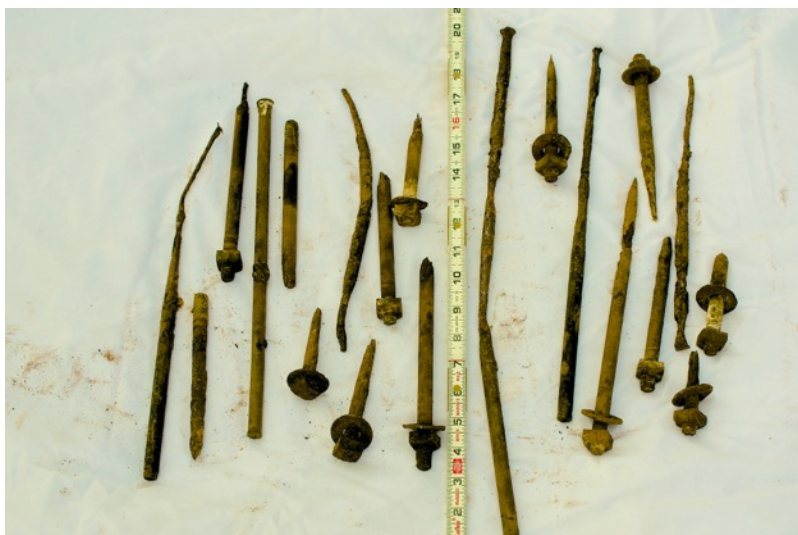
Sample of removed fastener

Some wastage was found in a few of the fasteners, but only a small number. (see the attached photos) Minor refastening was done. Overall the vessel was found to be tight and sound. The hull is sound.
