## VESSEL SURVEY REPORT

**This report is a summary of the findings of the survey performed on September 15, 2014 for Estate of Lester C. Gunther with the sole intent to determine the condition of the vessel for purchase, insurance and finance. One copy of this report are issued, an original with color photos. No other copies are authorized. This report contains proprietary information that is intended for the sole use of Estate of Lester C. Gunther is not sellable or transferable in any manner or form. This report is copyrighted under the copyright laws of the United States and any unauthorized reproduction, distribution or use is expressly prohibited. ©2013**

Vessel Name: **Sea Dog** Date of Survey: **September 15, 2014**

Type of Vessel: **Power Motor Yacht** Surveyed at: **Canal Boatyard, Seattle, WA**

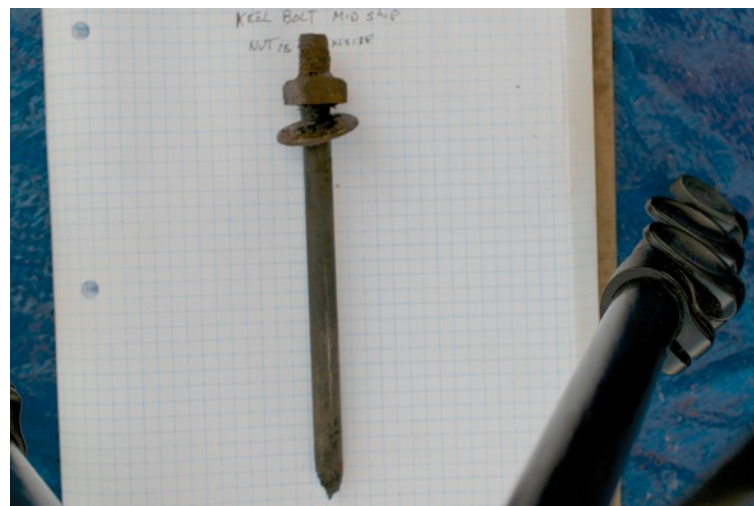
Inspection of the keel and the keel bolts, was made. Core samples were taken of the wood in the keel. The core samples showed the wood to be solid. Inspection of the keel bolts indicated that 21 of the bolts required replacement.

Keel Bolts that were removed from the vessel

New keel bolts were installed to original, 1/2" galvanized steel. (see the attached photos of the bolts that were removed.)
